**REMOVE - REFIT : BLIND SUB-ASSEMBLY :***5 DOOR ESTATE***1. Removing****Remove the roof lining**

(with panoramic roof) .

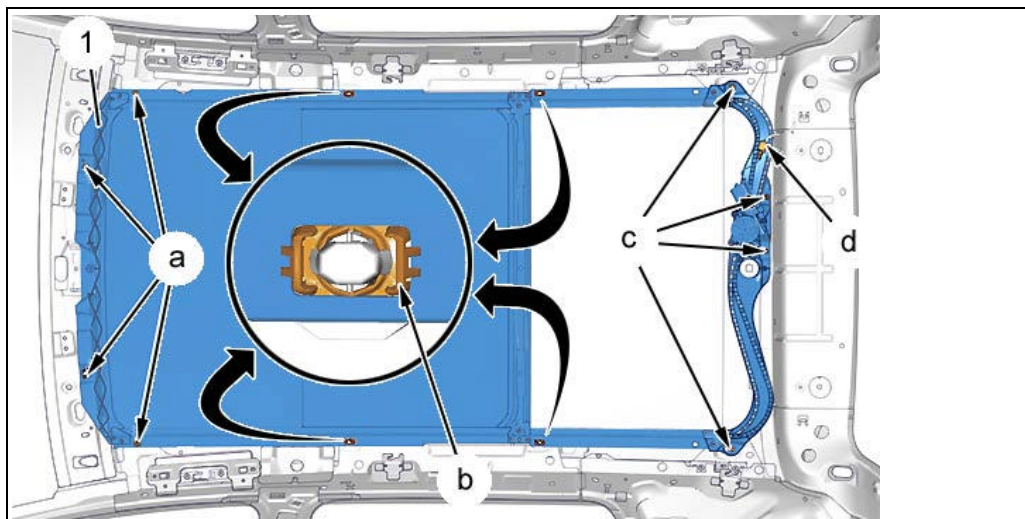
Figure : C4DM05AD

Remove :

- The bolts (at " a ")
- Nuts (at " c ")

Disconnect the connector (at " d ") .

Unclip : The blind sub-assembly (1) (at " b ") ; Using pliers .

**URGENT** : When unclipping do not pull on the blind sub-assembly to prevent distorting the frame .

Release the blind sub-assembly through the tailgate .

Remove : The blind sub-assembly (1) .

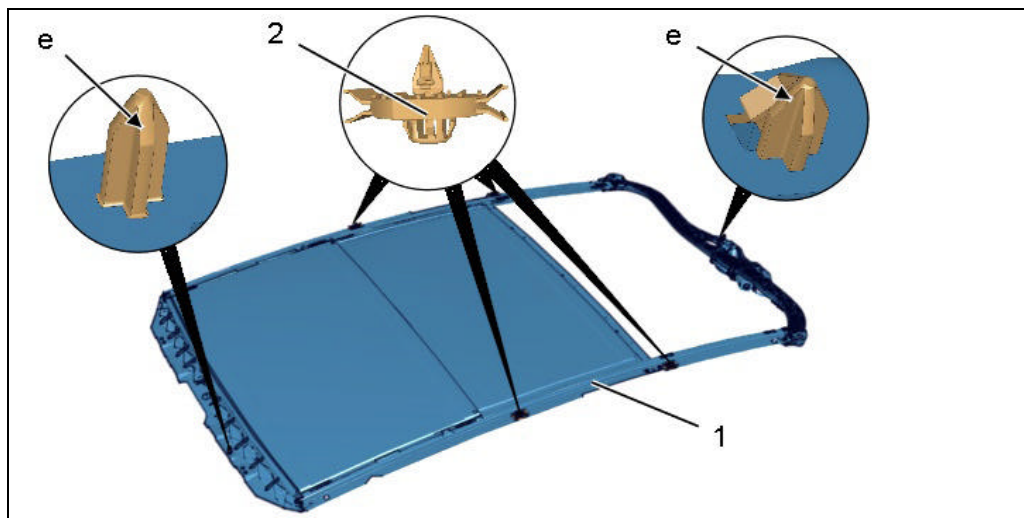
Figure : C4DM05BD

**N.B. :** Always replace the clips (2) .

Pre-position the blind sub-assembly (1) ; Using the pilot holes (at " e " ) .

Clip the blind sub-assembly (1) onto the clips (2) .

Pre-tighten the fixings (at "a" and "c") .

**URGENT :** Push hard onto the clips (2) .

The screws ; Tighten to  $0,2 \pm 0,05$  daNm (at " a " ) .

Nuts ; Tighten to  $0,75 \pm 0,2$  daNm (at " c " ) .

Connect the connector (at " d " ) .
